RESOLUTION 25-21

**A RESOLUTION TO AUTHORIZE THE EMERGENCY REPAIRS,
INSTALLATION AND PAYMENT OF CITY HALL WATER STORAGE
TANK**

RE: Emergency Repairs Proposal – City Hall 1MG Ground Supported Water Storage Tank

SPRING HILL CITY HALL GROUND STORAGE TANK REPAIR

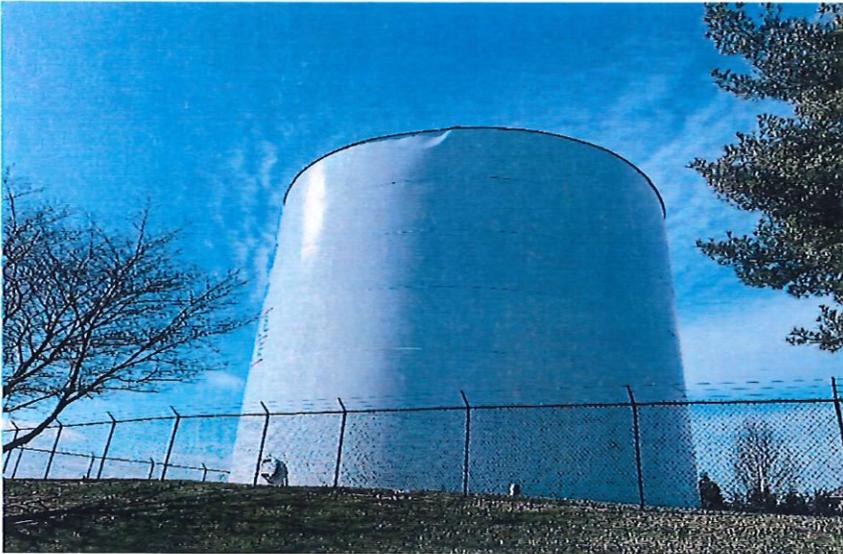
Photo shows an overall view of the area of the upper shell that was damaged during the overfilling event.

- 1. Remove an 8' x 12' section of the #6 upper shell where the rupture occurred causing the panel to warp including the rolled rim angle. Install a new 1/4" thick 8' x 12' upper shell panel and rim angle.**

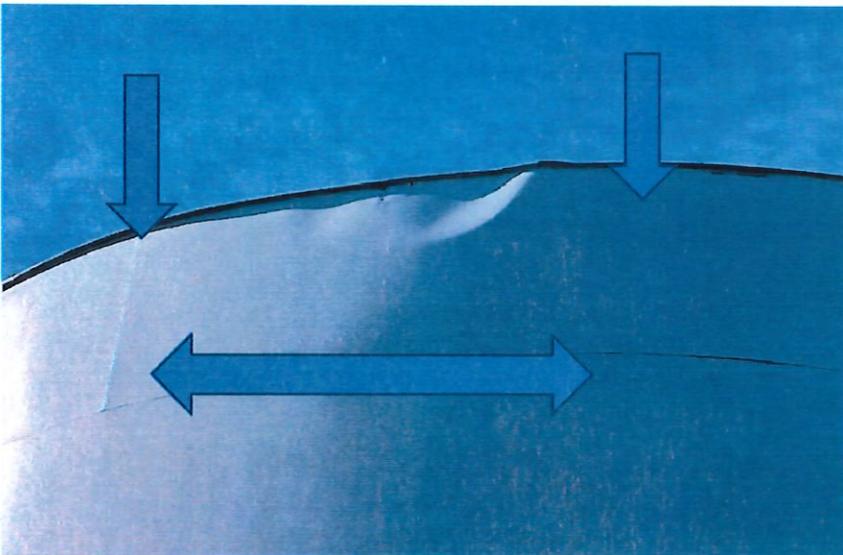
Photo shows an approximation of the area where the damaged upper shell panel will be removed and replaced.

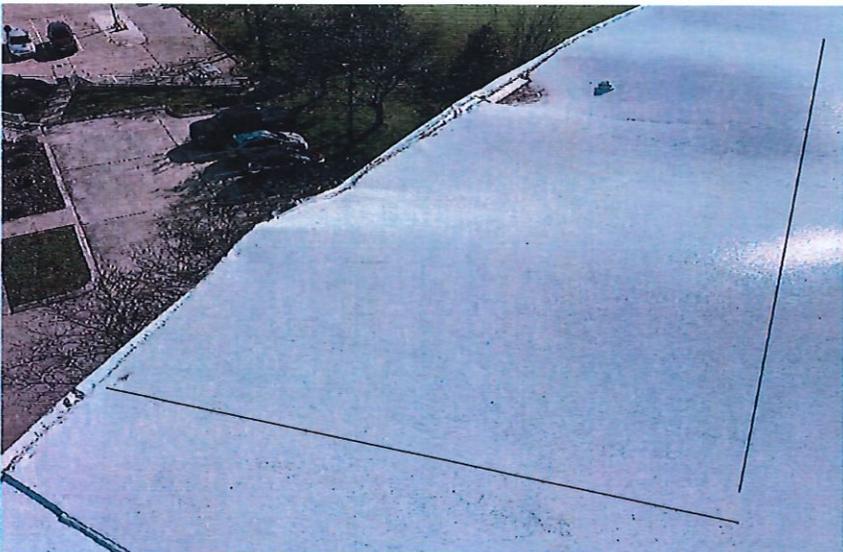
Photo shows an approximation of the area where the warped roof panel will be removed and replaced.

- 4. Remove and replace a 6' x 10' section of the outer roof panel where the failure occurred. The new panel shall be 1/4" thick.**
- 5. Install new lateral braces between all 32 channel beams. The braces shall be made from 2 1/2" x 2 1/2" x 1/4" steel angle. The new lateral supports shall be installed 4' from the shell and shall be welded to the existing and three new roof support channels. All support channels shall be moved back into proper alignment.**

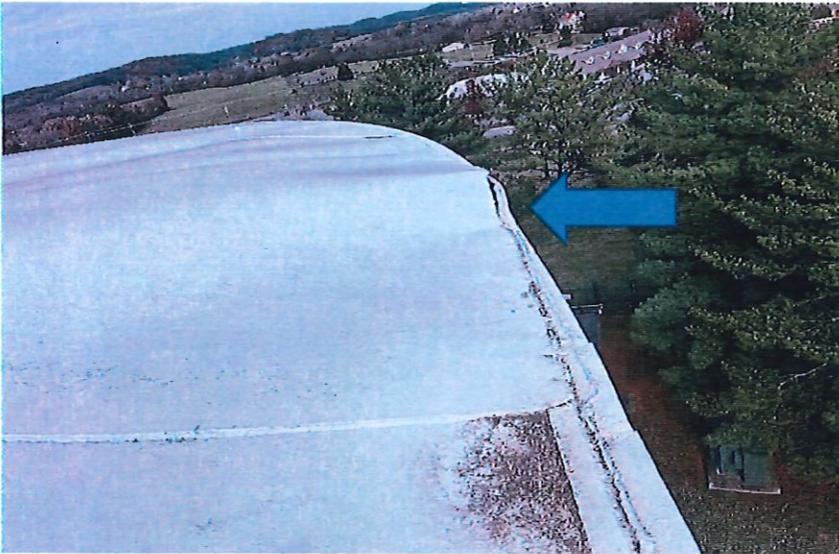
Photo shows another view of the damaged roof panel and the ripped roof to rim angle weld seam.

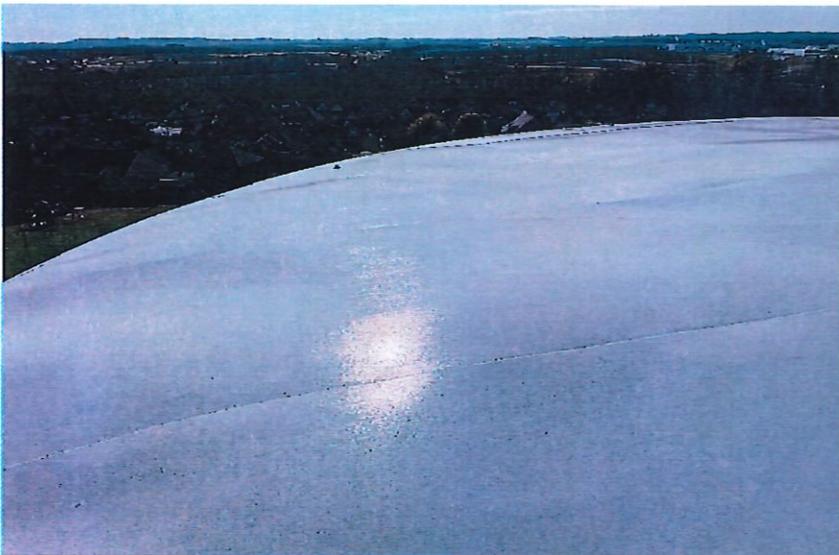
Photo shows the warping of the existing roof panels. The panels seams should be cut to allow the warped panels to settle along the roof support beams.

- 2. Cut the roof panel weld seams to allow the warpage in the panels to be removed.**
- 3. Remove and replace three 8" roof support channel beams. The channel beams on each side of the failed point and a third beam that has a double curve shall be replaced. (See attached photos)**

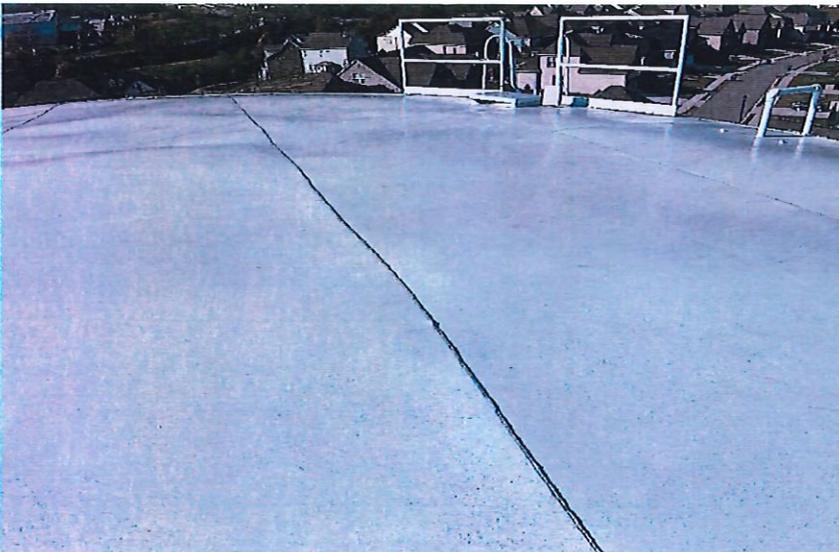
Photo shows another view of the warping along the roof panels.

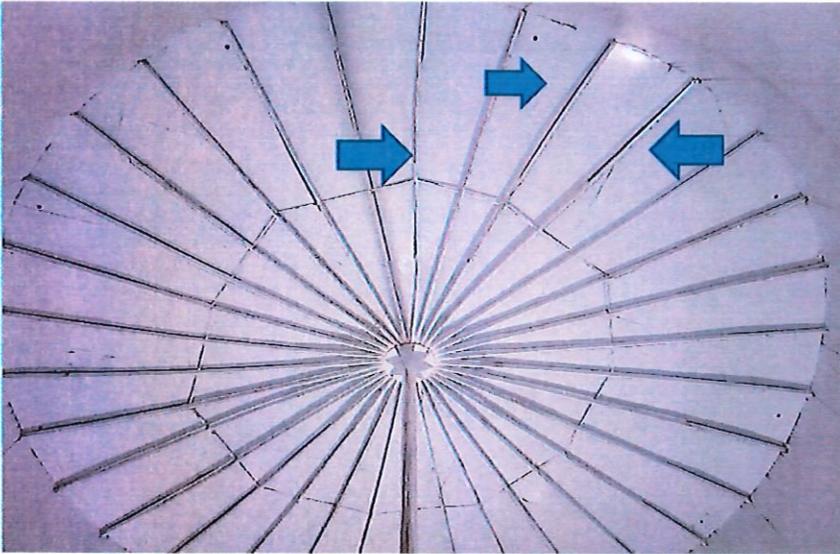
Photo shows the three damaged roof beams that will be removed and replaced.

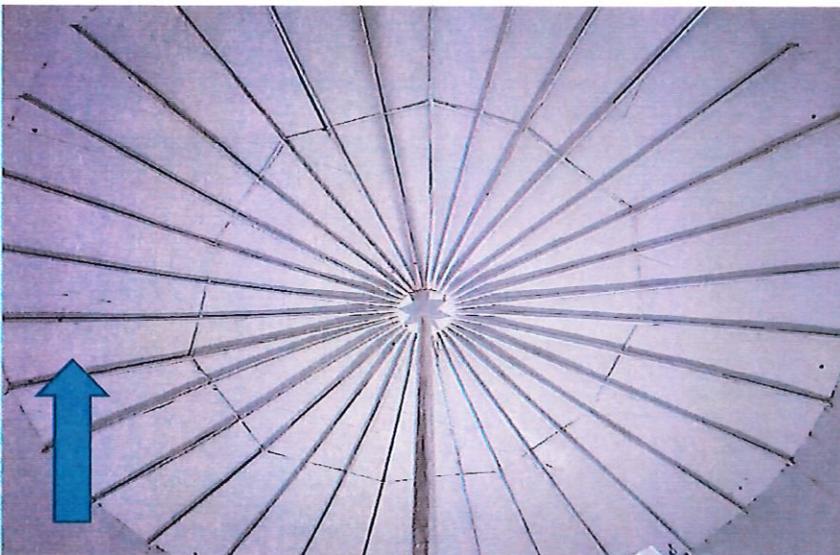
Photo shows an overall view of the roof structure and the area where new lateral bracing will be installed throughout the tank circumference.

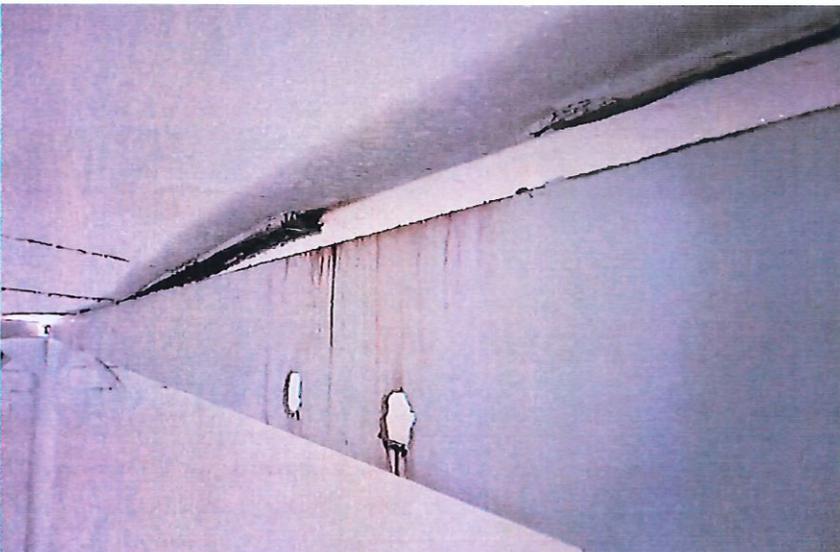
Photo shows an example of the warped roof panels lifted away from the roof support beam.

- 6. The roof panels shall be stitch welded to the roof support channels. Three-inch-long welds should be made every 3' on alternating sides of the channel beam flanges to remove the warpage from the roof panels and to control the gap between the roof panels and beams thus minimizing the amount of caulking required.**

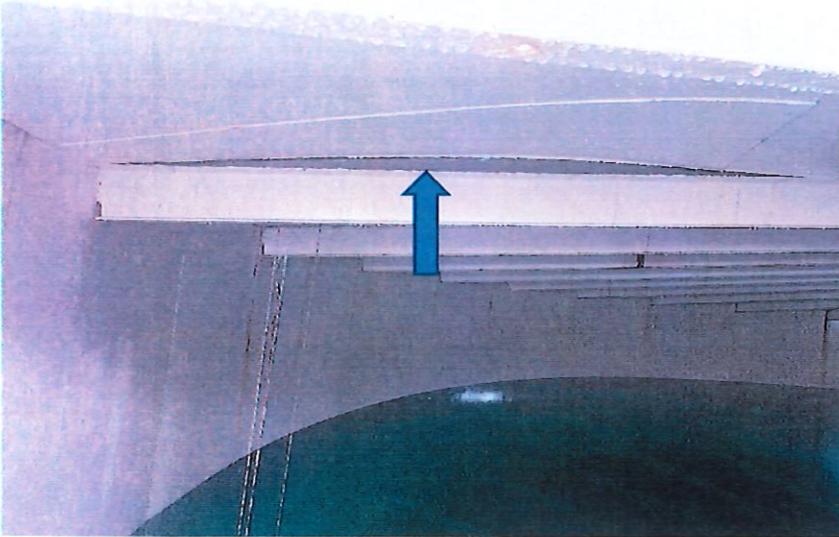
Photo shows another view of the warped roof panel above the roof support beams.

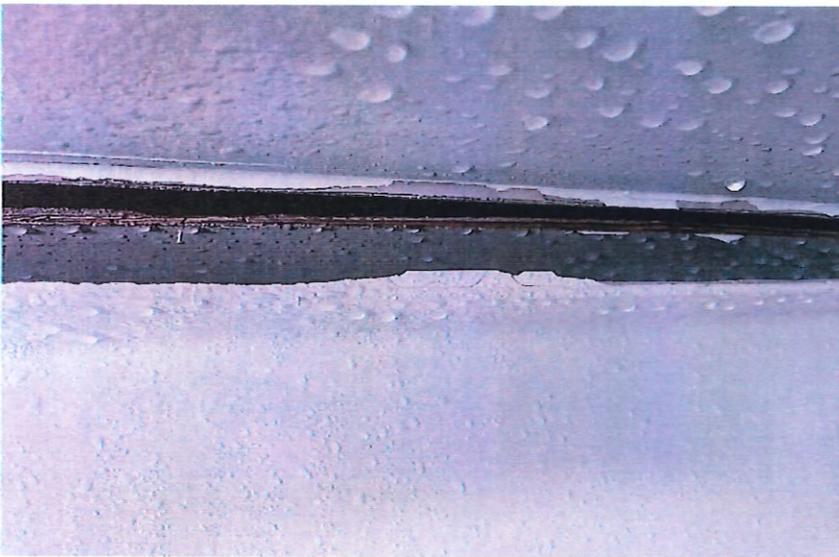
Photo shows an area where the roof panels have pulled away from the roof supports. The panels will be pulled back down the beam flange and stitch welded in place.
